**FINAL
ANNUAL LANDFILL CAP OPERATION AND
MAINTENANCE REPORT FOR 2019-2020**

Post-Removal Action, Parcel E-2, Industrial Landfill

HUNTERS POINT NAVAL SHIPYARD, SAN FRANCISCO, CA

July 2020

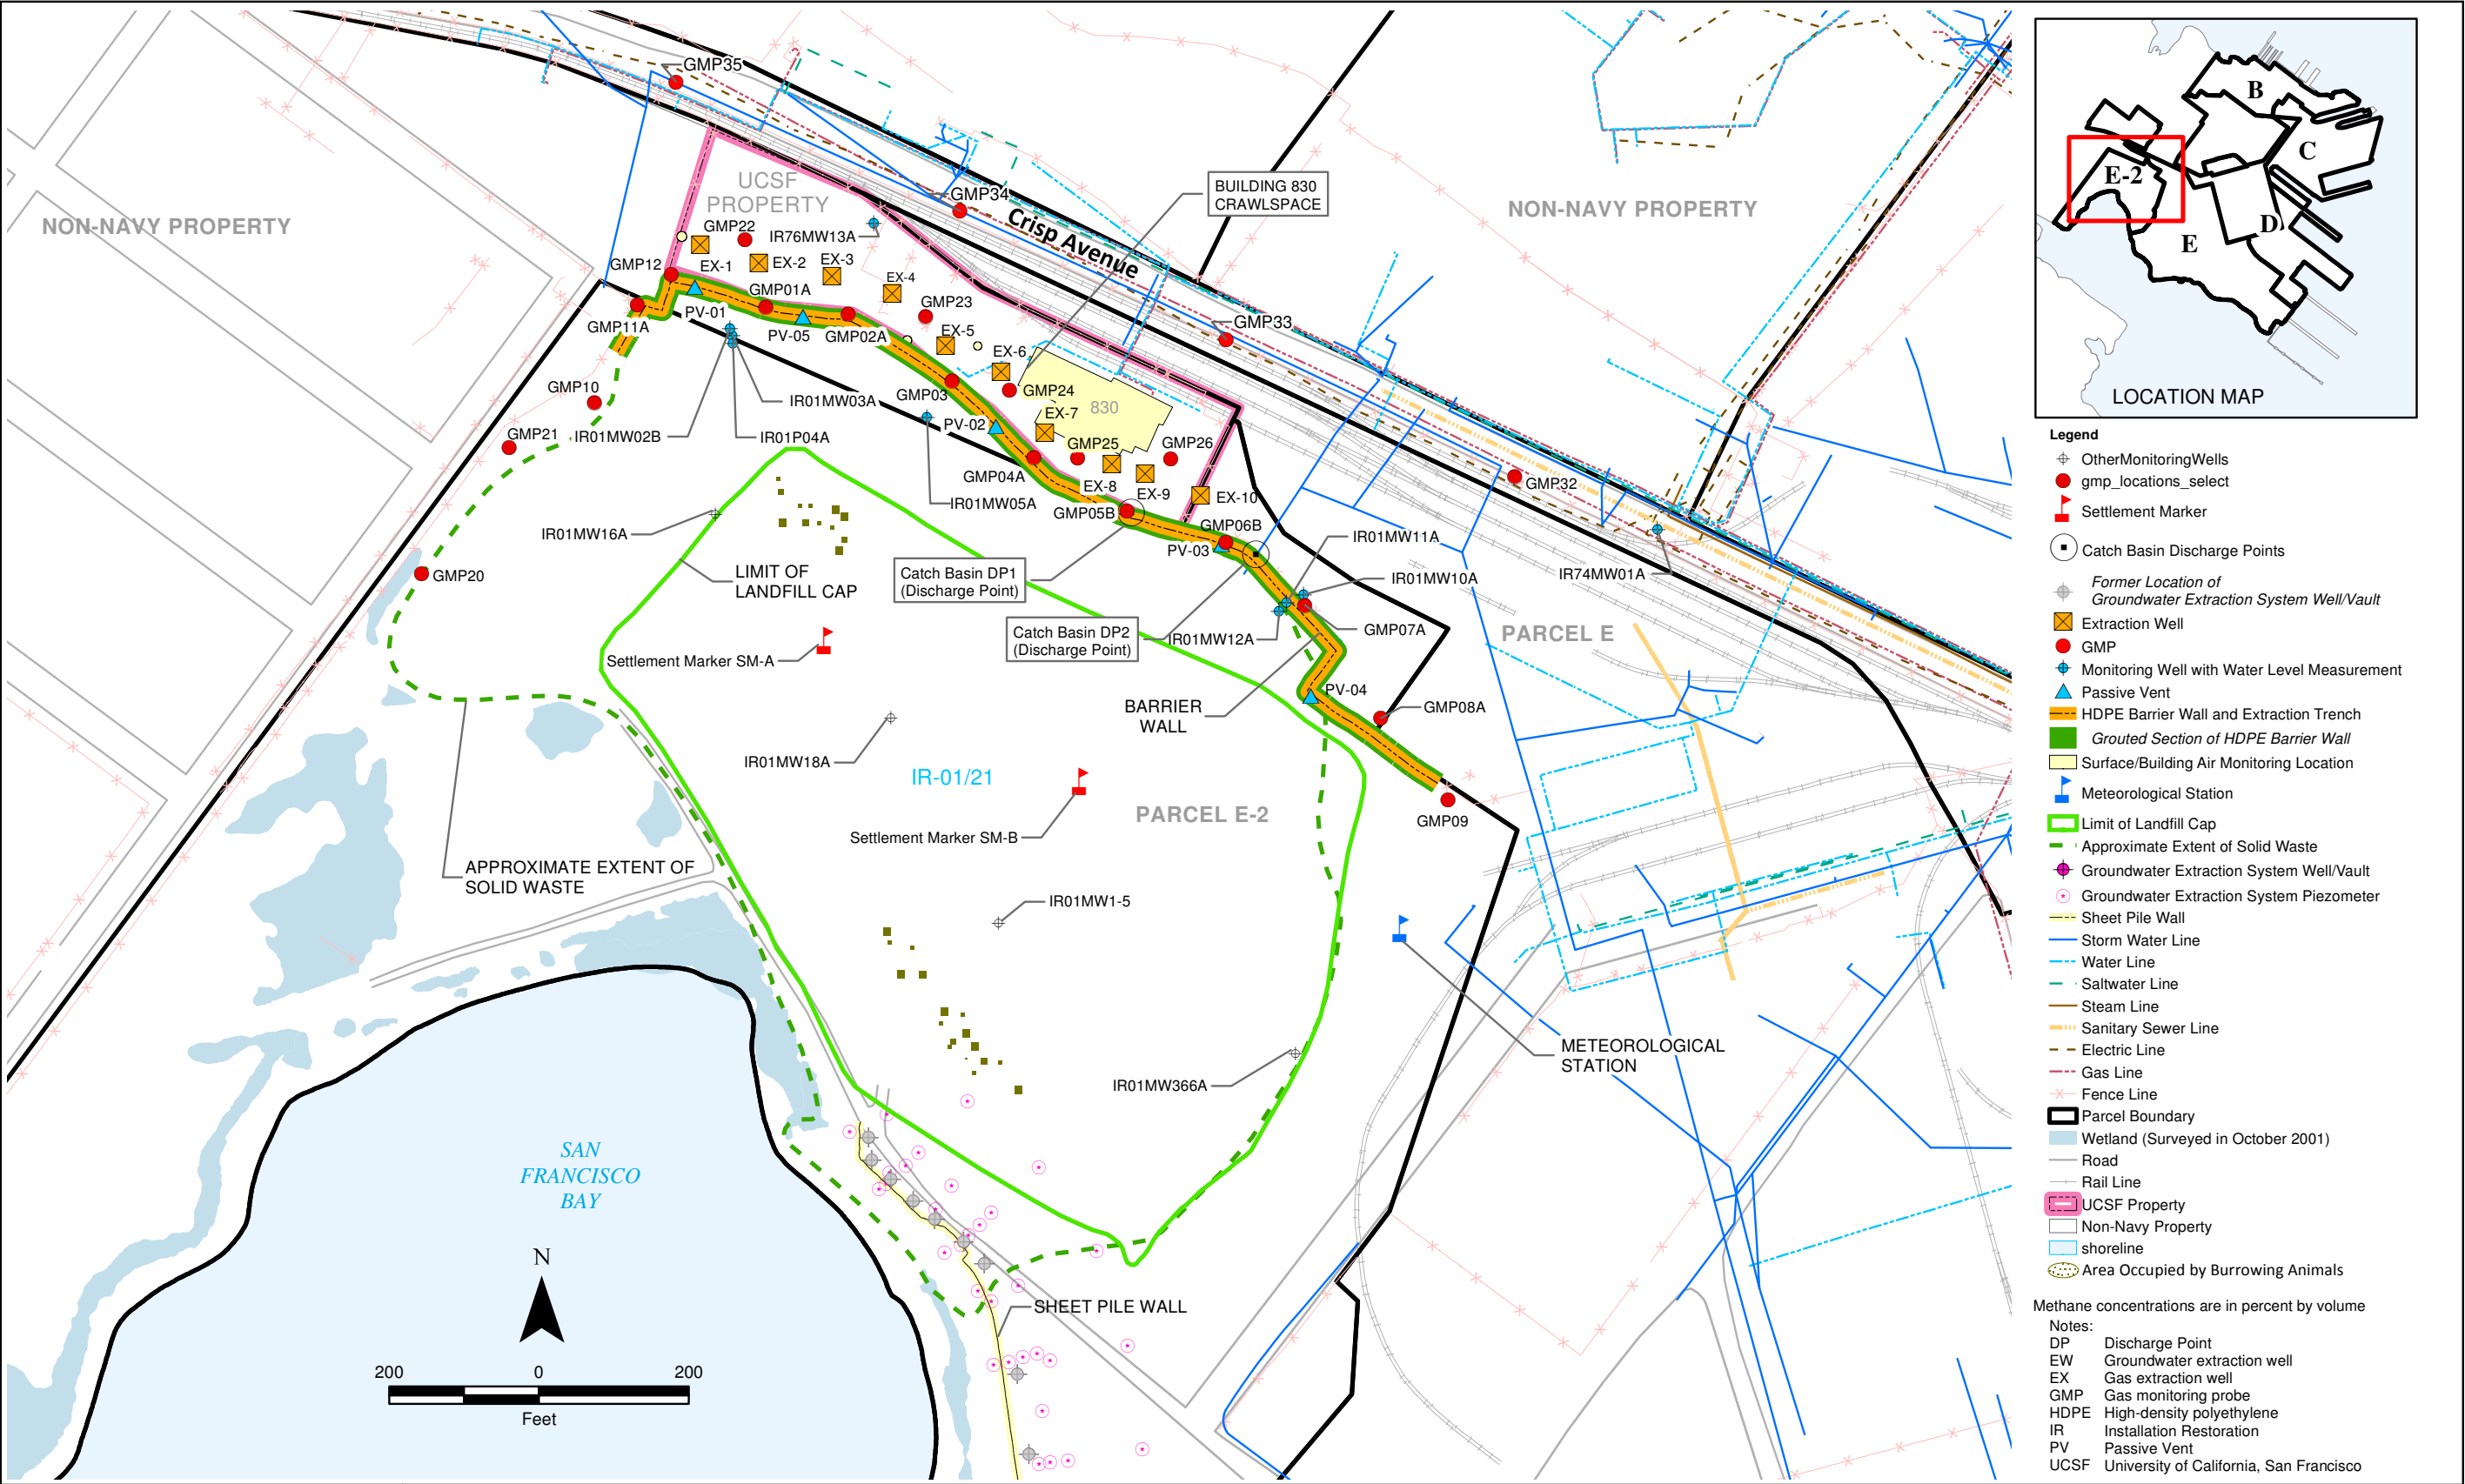
FIGURE 2
Site Map and
Landfill Gas Monitoring Locations

Vents. The vents located along the barrier wall and extraction trench were examined on March 12, 2020, and individual carbon vessels at PV-04 and PV-05 were observed to have rust holes on the drum tops (see Figure 2 for locations). After consultation with the Navy, all vessels at both locations (a total of four carbon drums and two Hydrosil drums) were replaced in May 2020. A reading of 6.4% methane was made at monitoring point GMP01A along the barrier wall on March 12, 2020 causing the need to use the second “active” vent blower system, at location PV-05. The second system required repairs, as well as, ironically, the primary “active” vent blower system at location PV-02. Repairs to both systems were made in May 2020, and the second system was operational for ten days from May 26, 2020 through June 4, 2020. Monitoring results from May 28, 2020 and May 29, 2020 confirmed that the methane concentration in GMP01A had been reduced to 0.0%.

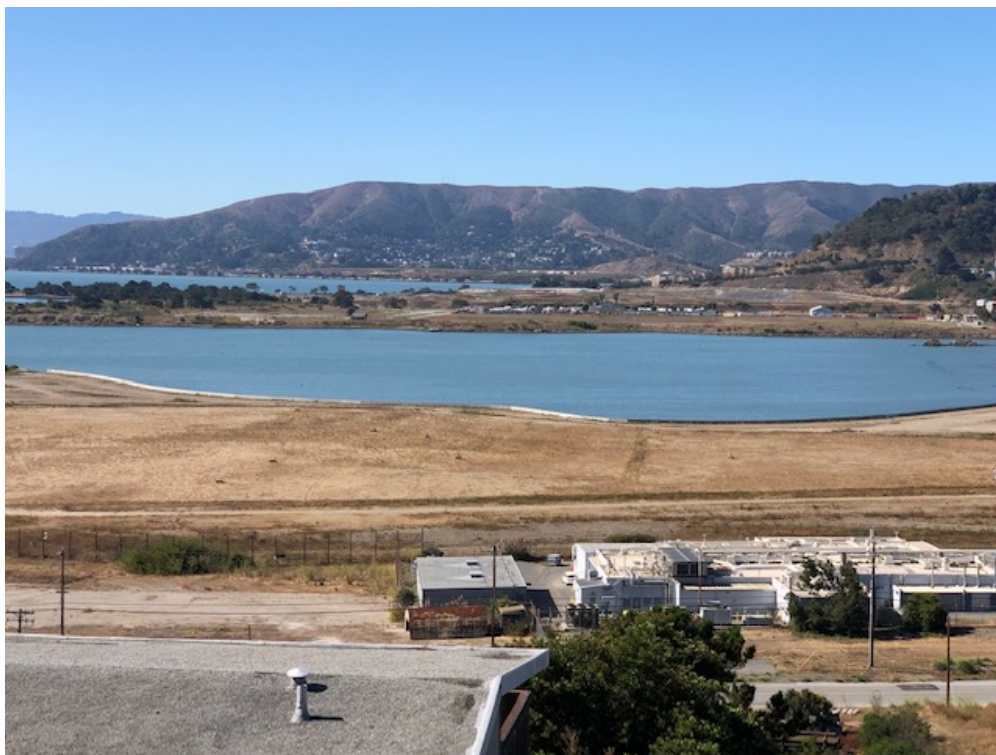
Photo #1 (September 2019) – View of landfill looking south.

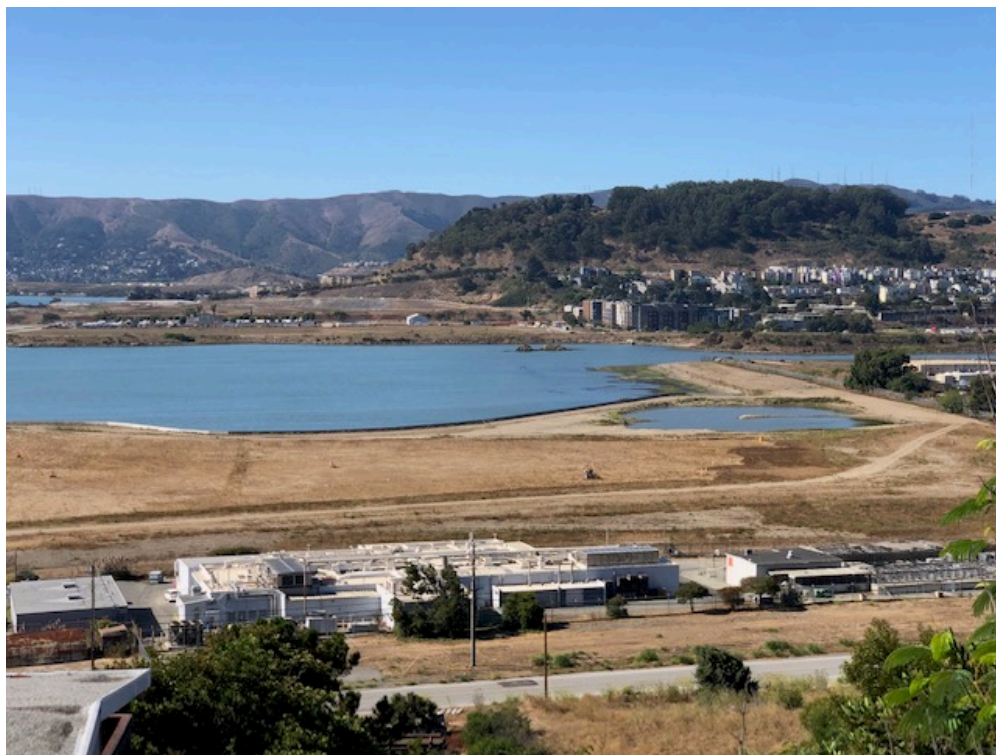
Photo #2 (September 2019) – Photo of western part of landfill looking south/southwest.

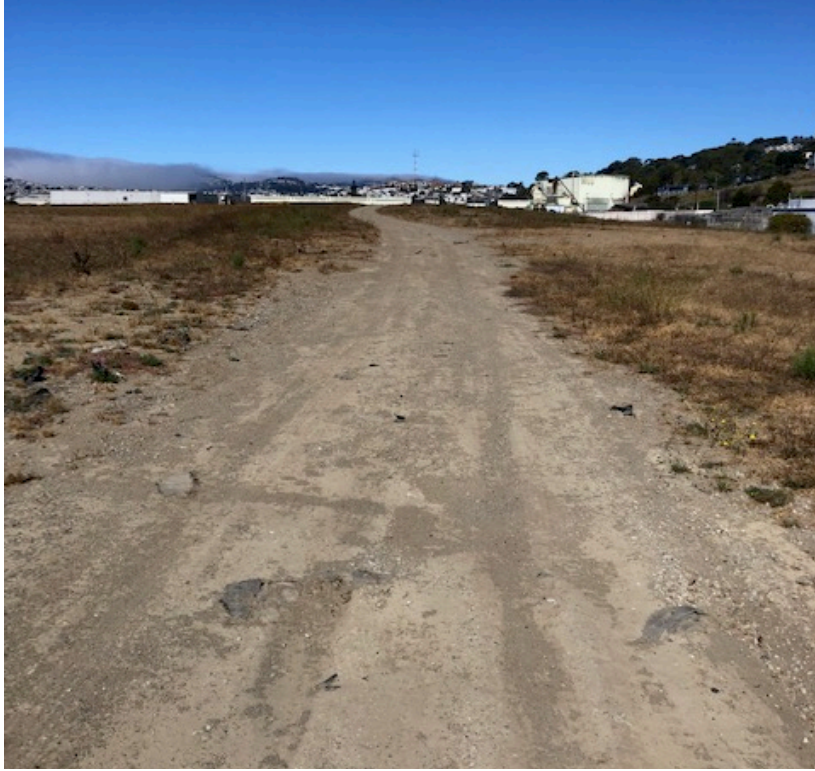
Photo #3 (September 2019) – View of perimeter road on north side of landfill.

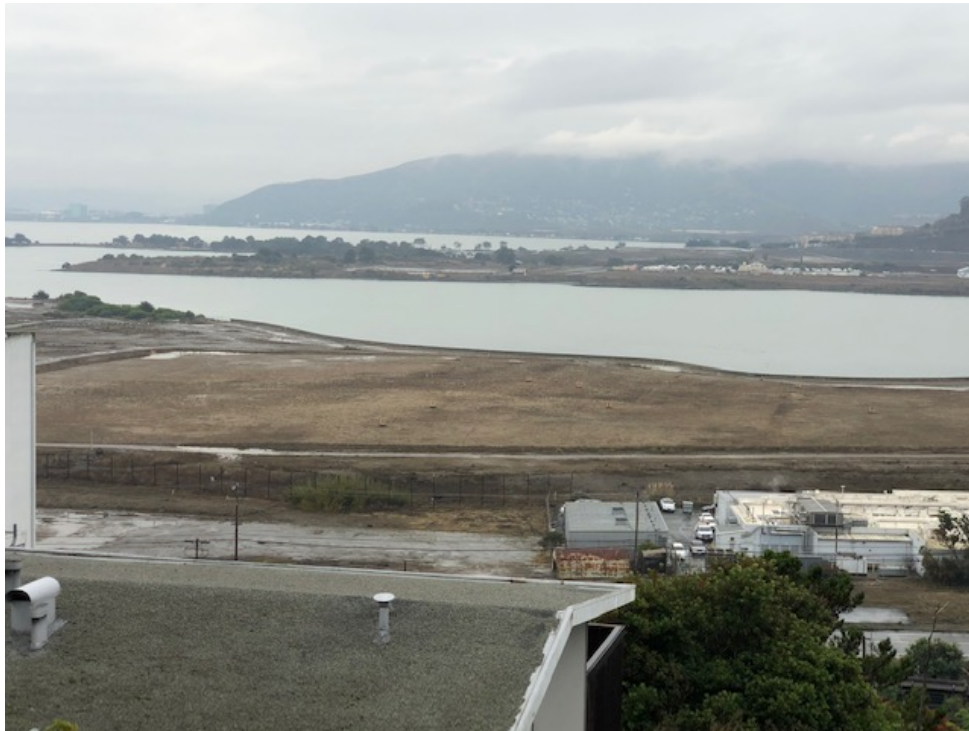
Photo #4 (December 2019) – Photo of landfill looking south.

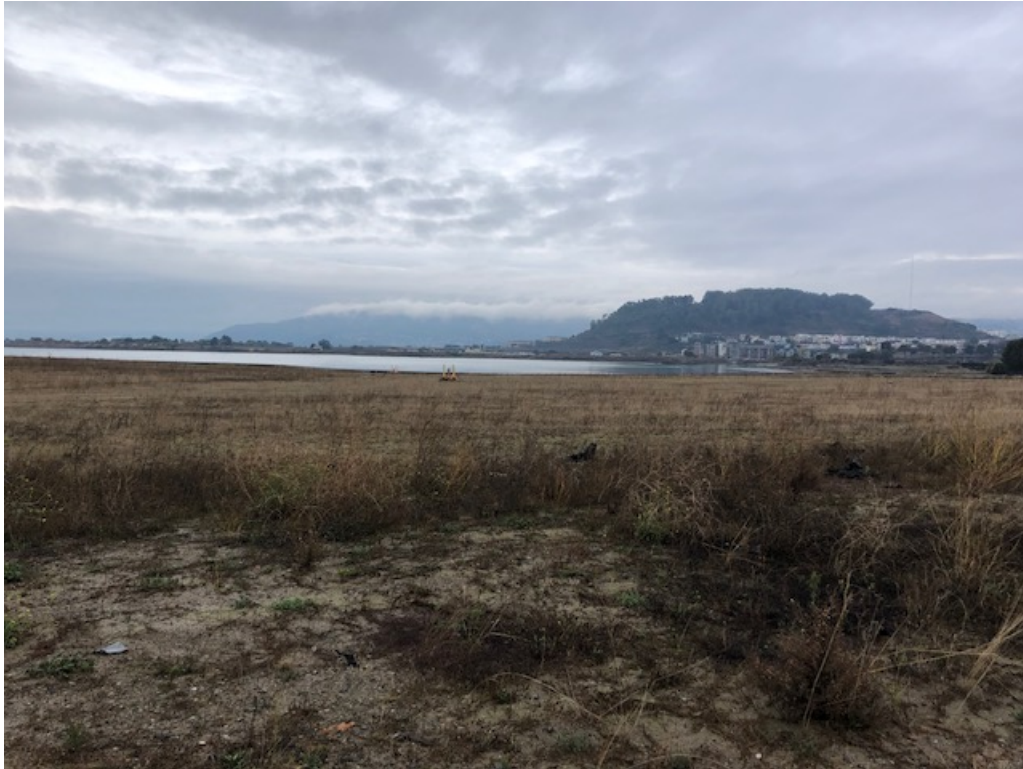
Photo #5 (June 2019) – View of landfill looking south from north perimeter road.

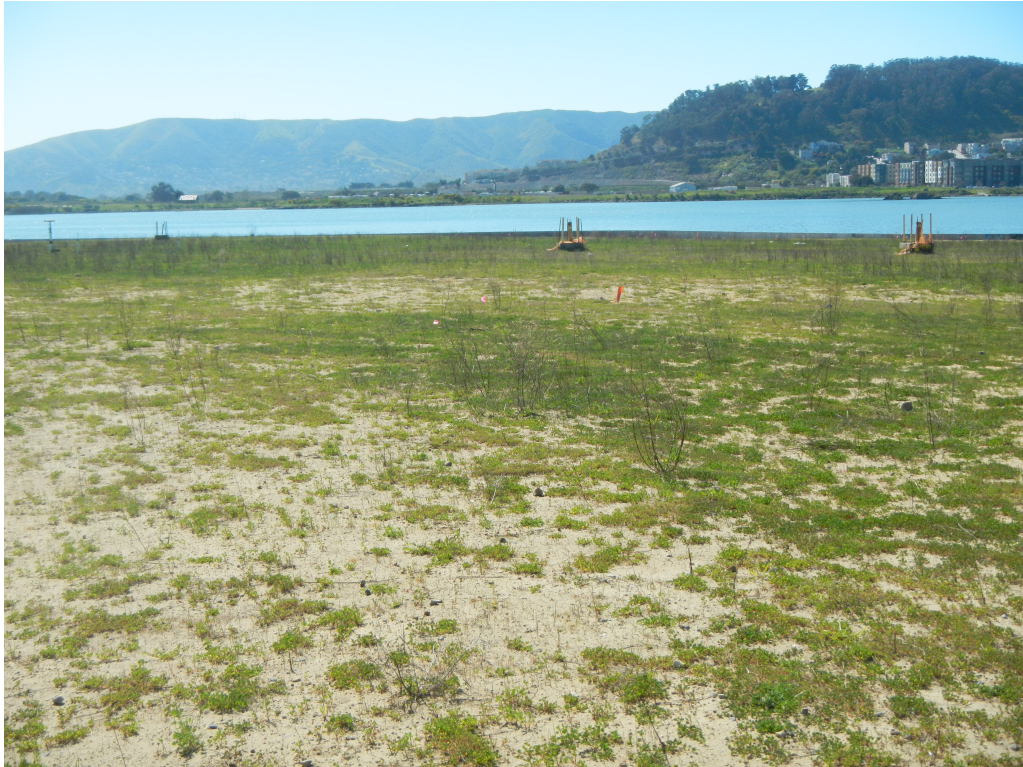
Photo #6 (March 2020) – View of landfill cap looking south
